6 National Dam Inspection Program. Frances Slocum Dam (NDS-ID-PA-00574; DER-ID-40-218), Susquehanna River Basin, Abrahams Creek, Luzerne County, Pennsylvania. Phase I Inspection Report.

FRANCES SLOCUM DAM

NDS ID No. PA-00574
DER ID No. 40-218

PHASE I INSPECTION REPORT
NATIONAL DAM INSPECTION PROGRAM

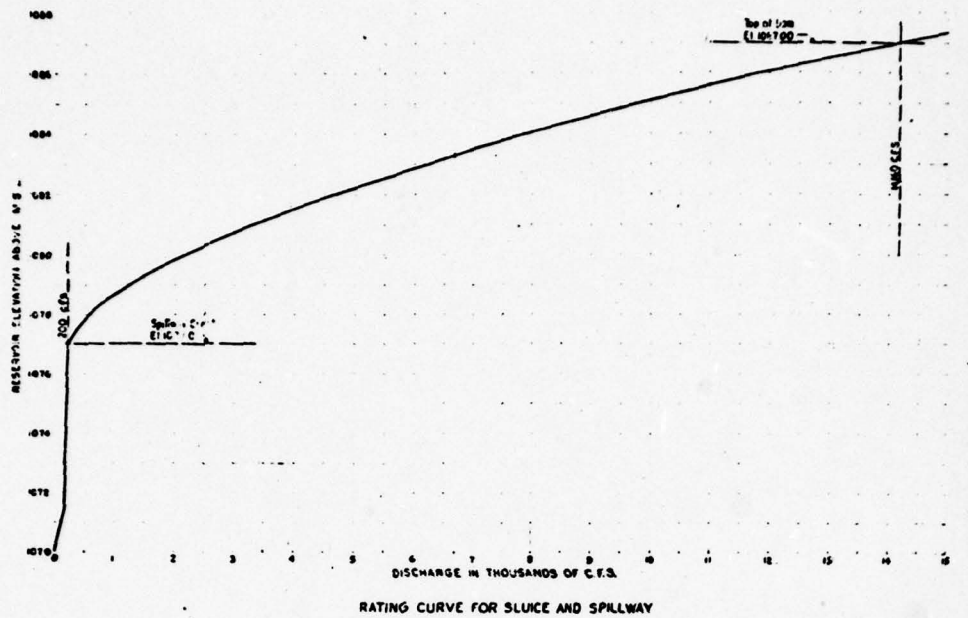
PHASE I INSPECTION REPORT
 NATIONAL DAM INSPECTION PROGRAM
 FRANCES SLOCUM DAM
 COMMONWEALTH OF PENNSYLVANIA
 OUTLET WORKS
 SEPTEMBER 1978
 PLATE 8

The outlet works is situated along the original streambed and consists of an intake structure at the upstream toe of the embankment, a 30-inch diameter concrete outlet conduit through the embankment, and a gate structure located just upstream from the axis of the dam (Plate 8). As originally constructed, an outlet structure was located at the downstream toe of the embankment. However, as part of highway construction adjacent to the right abutment, PennDOT extended the outlet conduit to a manhole located in the highway fill. A 42-inch diameter concrete pipe leads from the manhole to the stream channel. The intake structure is concrete and it has a trashrack. The 30-inch diameter outlet conduit is on a concrete cradle founded on rock. Seepage collars are located at 15-foot intervals along the conduit. The gate structure shelters
